**REPORT OF THE PUBLIC PROTECTOR IN TERMS OF SECTION 182(1)(b) OF THE
CONSTITUTION OF THE REPUBLIC OF SOUTH AFRICA, 1996 AND SECTION 8(1) OF
THE PUBLIC PROTECTOR ACT, 1994**

REPORT NUMBER: 10 OF 2025/2026

**INVESTIGATION INTO ALLEGATIONS OF MALADMINISTRATION, IMPROPER
CONDUCT AND FAILURE BY THE FUNCTIONARIES OF VHEMBE DISTRICT
MUNICIPALITY AND MUSINA LOCAL MUNICIPALITY TO MAINTAIN THE SEWAGE
INFRASTRUCTURE AT MUSINA, MATSWALE PHASE 10, WARD 5**

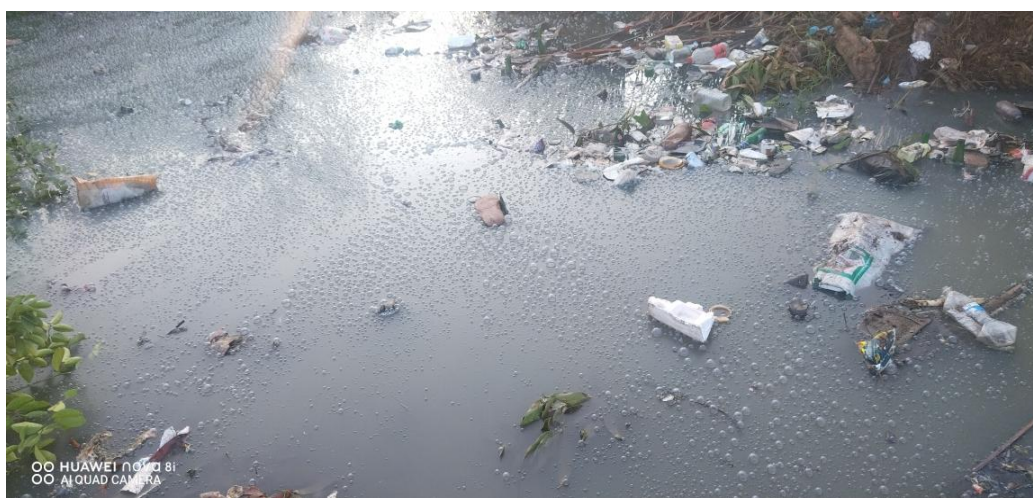
- 2.2.5 The Complainant provided the Public Protector Investigation Team (Investigation Team) with the pictures shown below depicting the state of the condition in Matswale Phase 10, Ward 5:

Picture 1: Spillage and wastewater at Matswale Phase 10, Ward 5

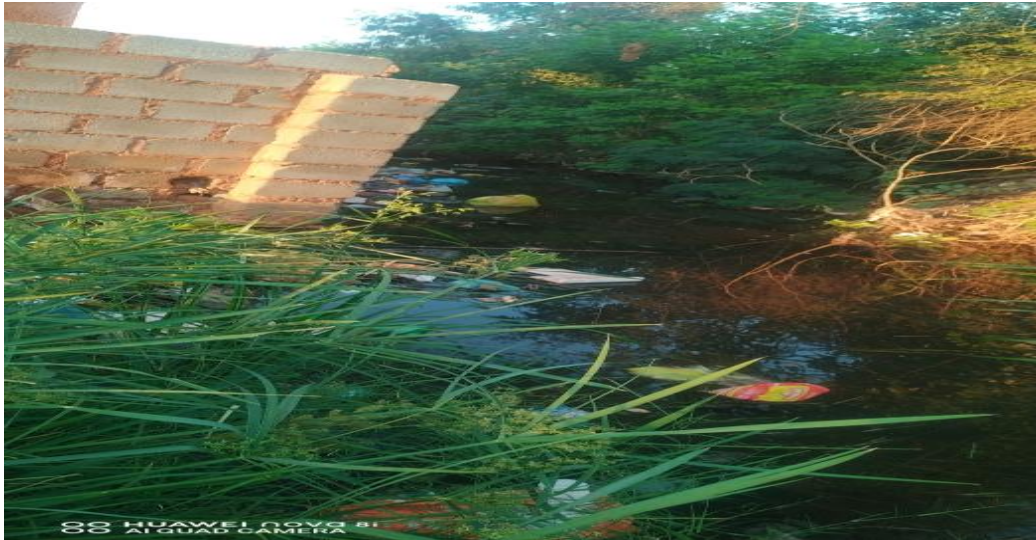
Picture 2: Water stream and overgrown vegetation

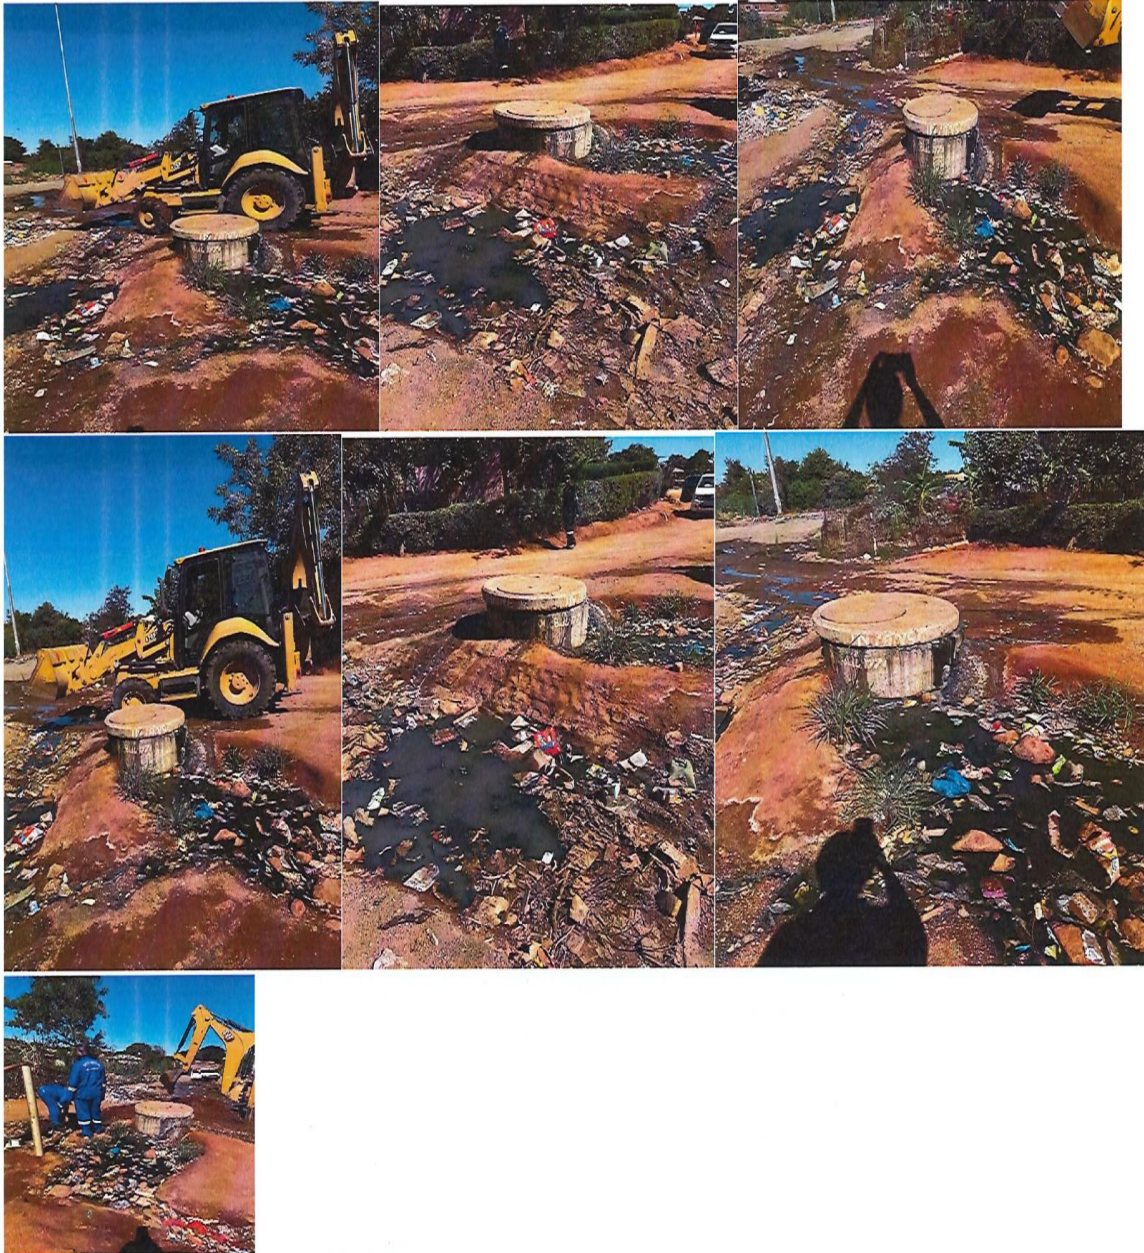
BEFORE

- 6.1.11.3 The sewer maintenance team would unblock the pipeline; however, it will recur due to the amount of sand that has infiltrated the sewer pipe;

Picture 3: Before repairs at Matswale Phase 10, Ward 5 (Courtesy of VDM)

- 6.1.11.7 The Municipality together with the contractor will replace the broken sewer line and flush out the infiltrated sand along the collector pipeline and manhole to ensure that the sewage flows without any blockages;
- 6.1.11.8 The anticipated completion period for the replacement of the pipeline and flushing was 05 July 2024;
- 6.1.11.9 Concerning by-laws, the Municipality is in the process of promulgating water service by-laws, which are inclusive of sanitation aspects and its environmental impact (Policy at the drafting stage); and
- 6.1.11.10 The Municipality assured the Public Protector that all corrective measures are regarded as high priority, to ensure that the Municipality remedies the spillages affecting residents in Matswale Phase 10 in Musina.

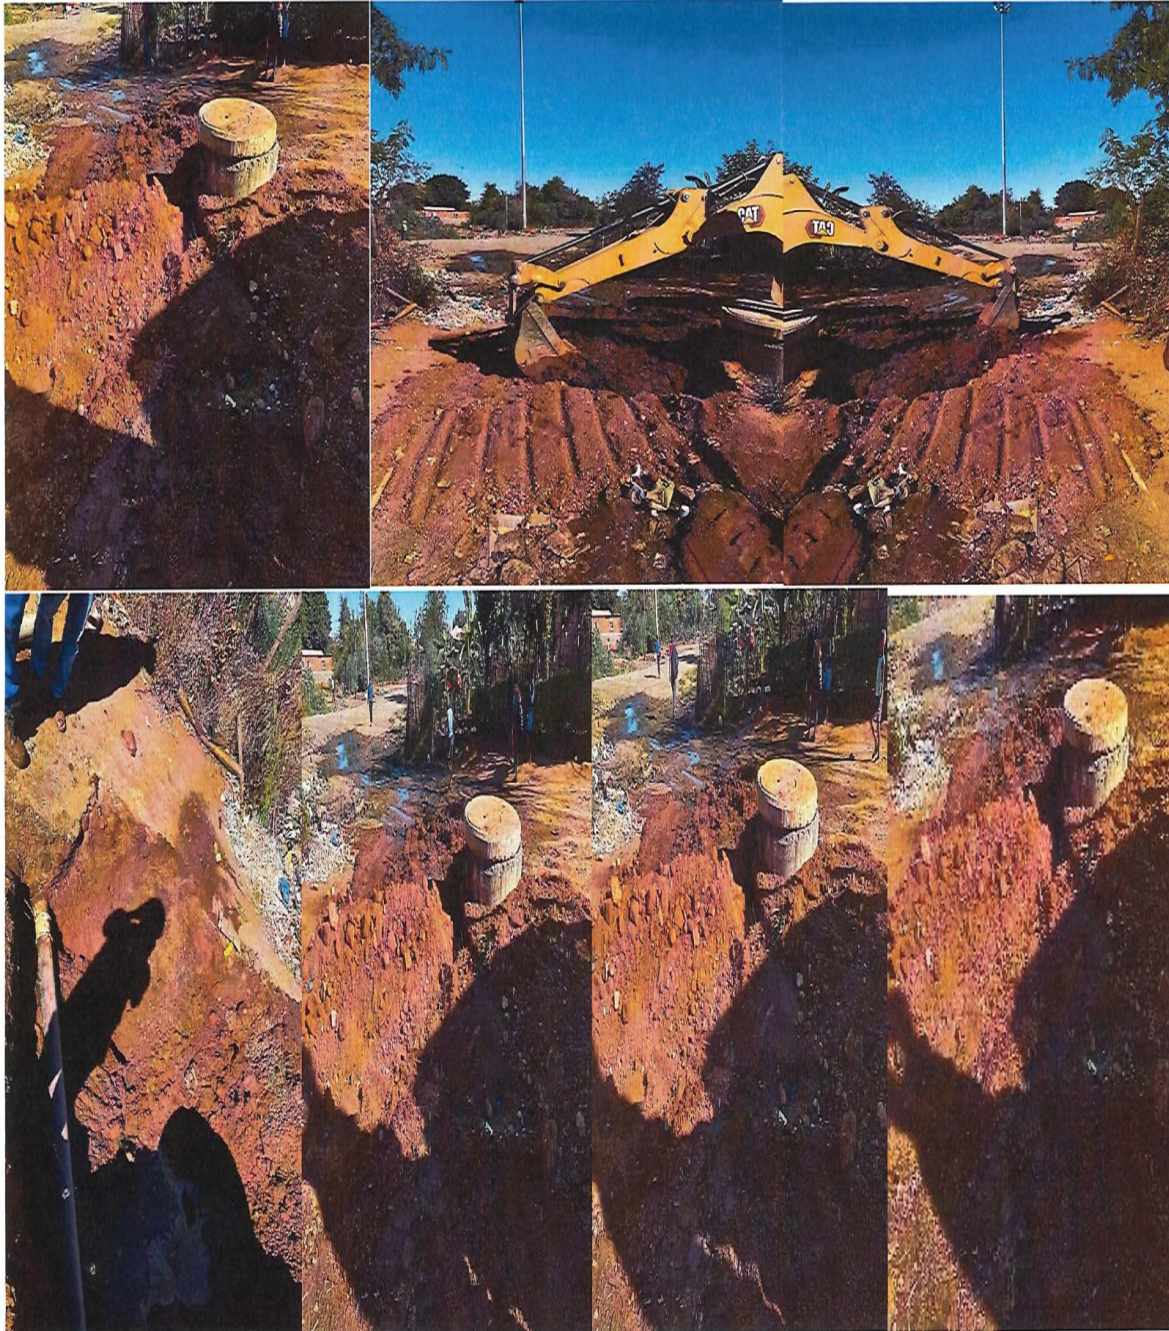
AFTER

Picture 4: shows after the repairs at Matswale Phase, Ward 5 (Courtesy of VDM)

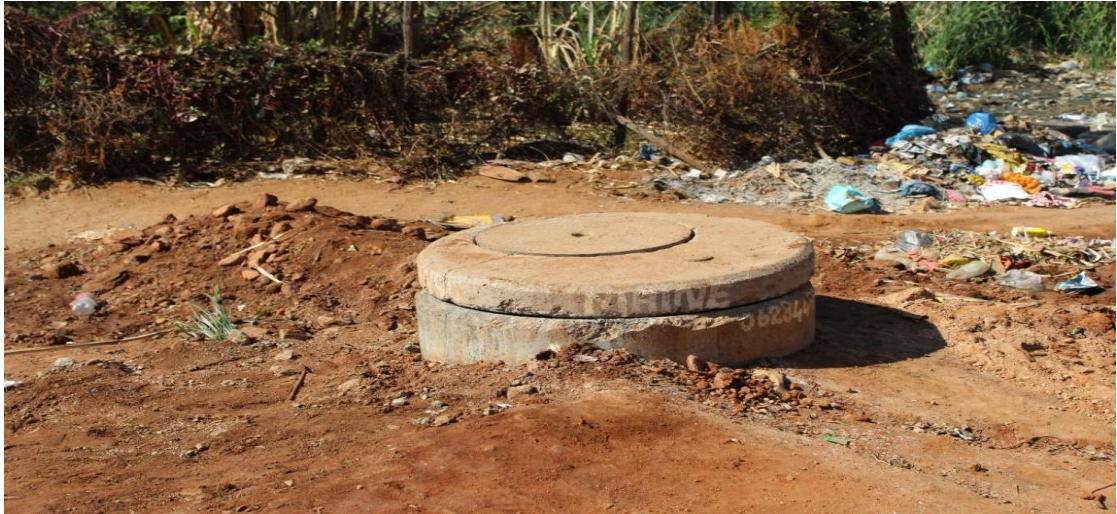
- 6.1.19 On 18 July 2024, the Investigation Team, together with the Complainant and the maintenance supervisor of VDM, Mr Timothy Mbedzi (Mr Mbedzi), conducted an inspection *in loco* at Matswale Phase 10, Ward 5.
- 6.1.20 During the inspection, the Investigation Team observed that the sewage pipe and the manhole had been repaired and there was no sewage spilling as shown in the pictures below.

Picture 5: Repaired sewer pipe

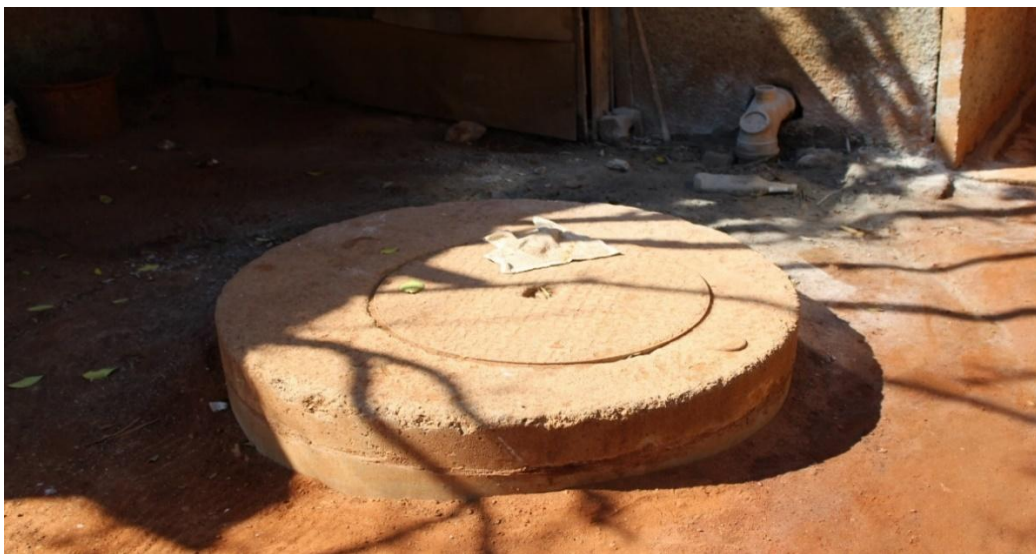
- 6.1.21 However, dry raw sewage was visible, the area was extremely dirty, and the stench of sewage was overwhelming.

Picture 6: Dry sewage after repairs at Matswale Phase 10

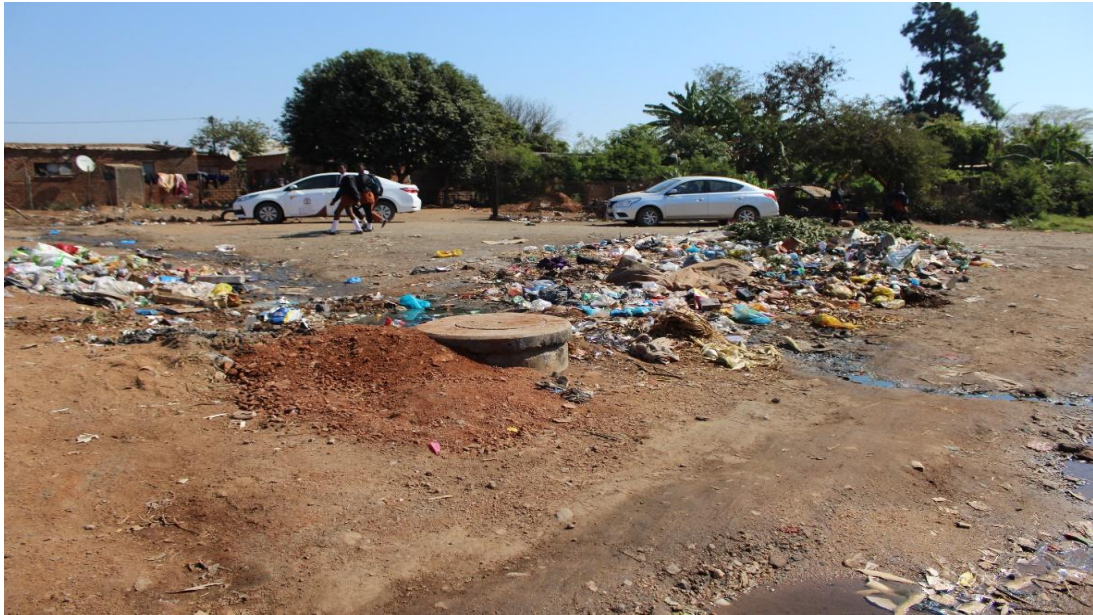
Picture 7: Repaired manhole but the area was dirty

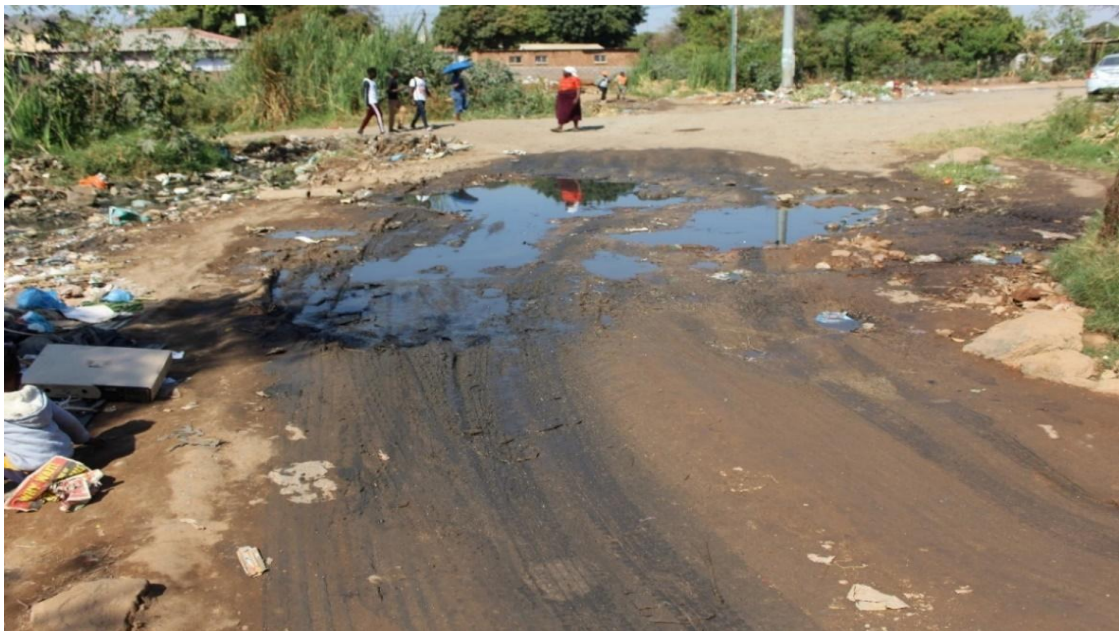
- 6.1.22 In addition, the Investigation Team also observed water from a nearby stream mixed with raw sewage, which had spilled over the area as shown in the picture below.

Picture 8: Smelly waterway where sewage was flowing at Matswale Phase

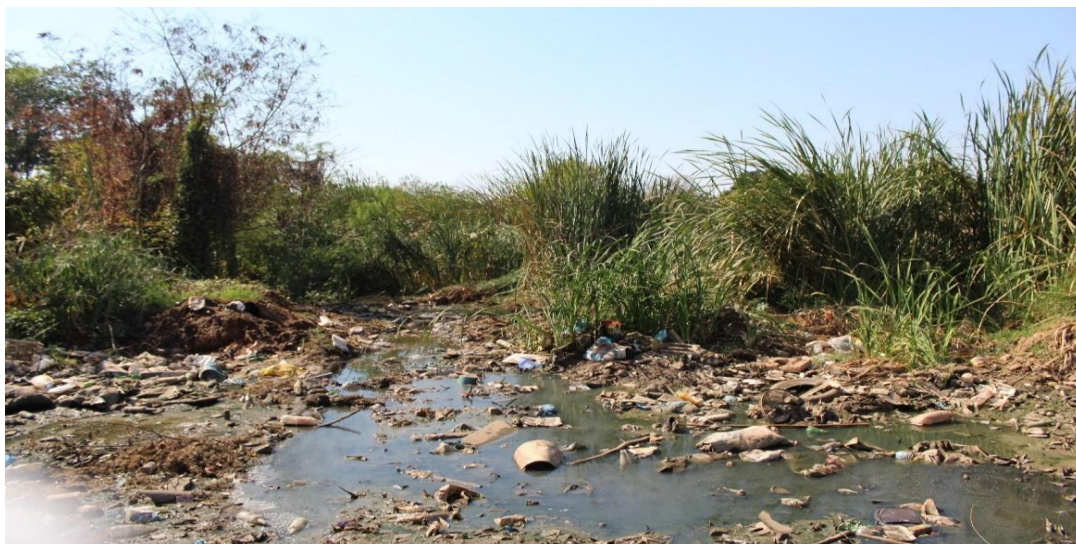
- 6.1.23 In addition, sewage had overflowed into the nearby water stream, which had overgrown vegetation, and rubble was not collected.

Picture 9: Stream with grown vegetation

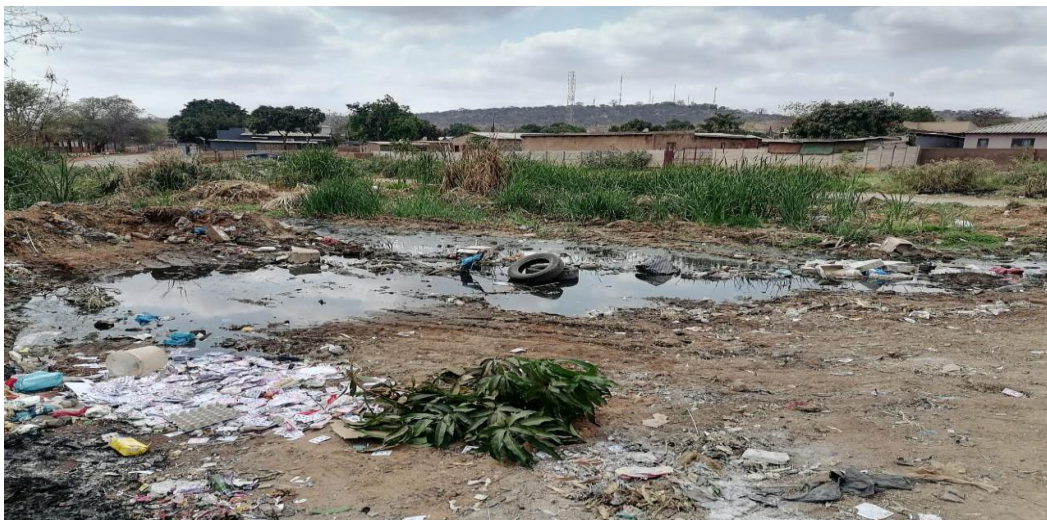
Picture 10: The area after the TLB has removed some of the rubbish

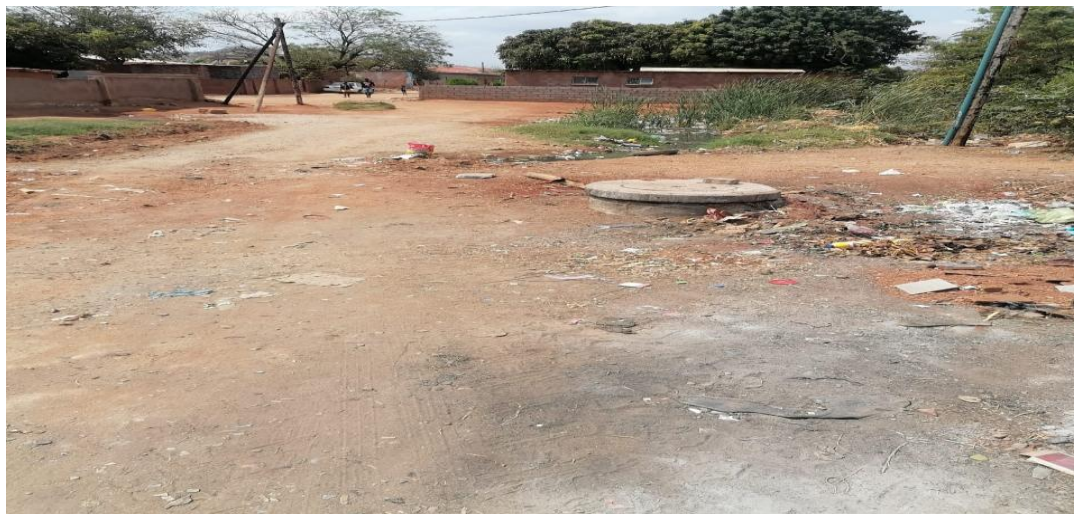
- 6.1.31 The picture below shows the road after it was covered with dry soil in an effort to eliminate the sewage smell.

Picture 11: Road after being covered with dry soil

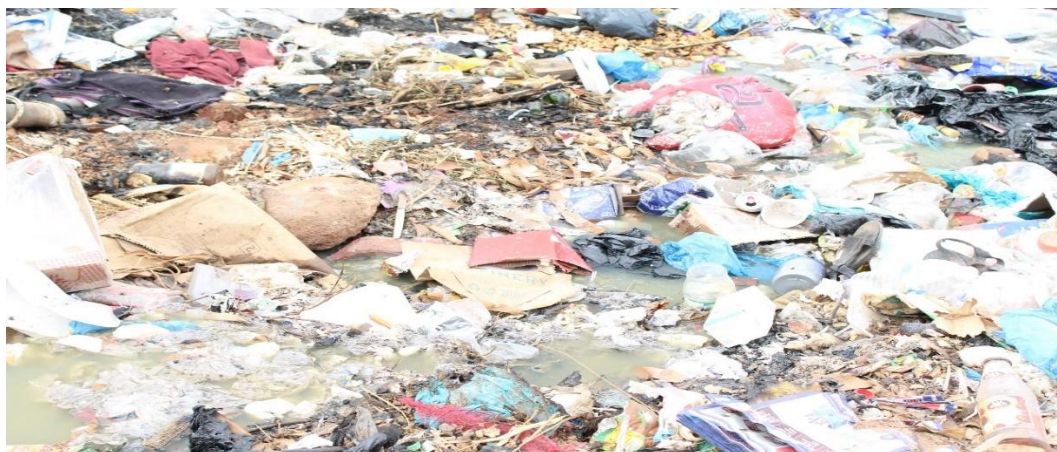
- 6.1.32 On 12 March 2025, the Investigation Team conducted a follow-up inspection *in loco* to assess the current conditions of Matswale Phase 10, Ward 5 and discovered that the area was still full of waste and sewage spillage, though VDM had previously attended to the spillage as shown below.

Picture 12: Raw sewage and refuse

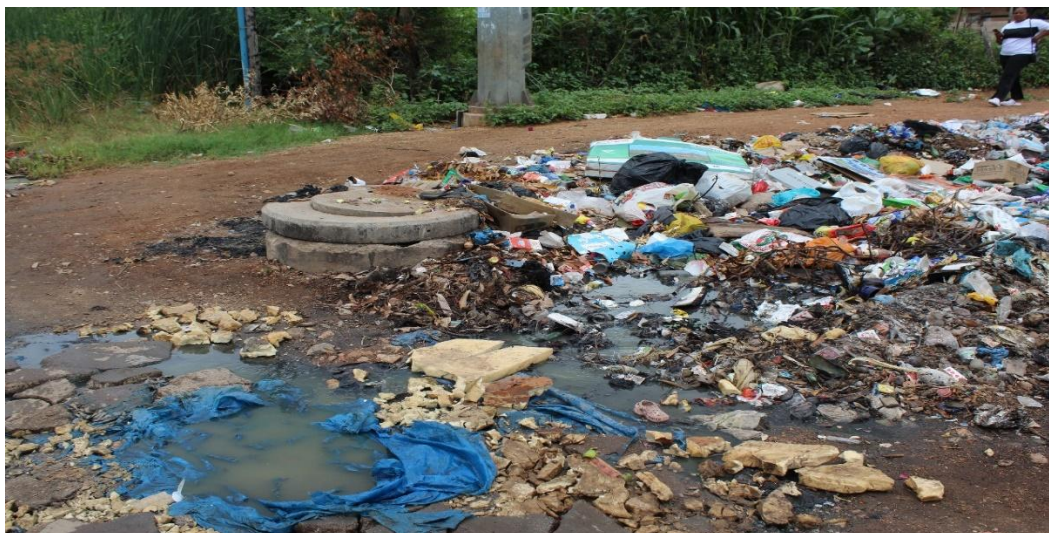
- 6.1.33 A lot of refuse had again accumulated around the manhole and was mixed with raw sewerage spillage as observed during the on-site inspection.

Picture 13: The manhole, sewage and rubbish

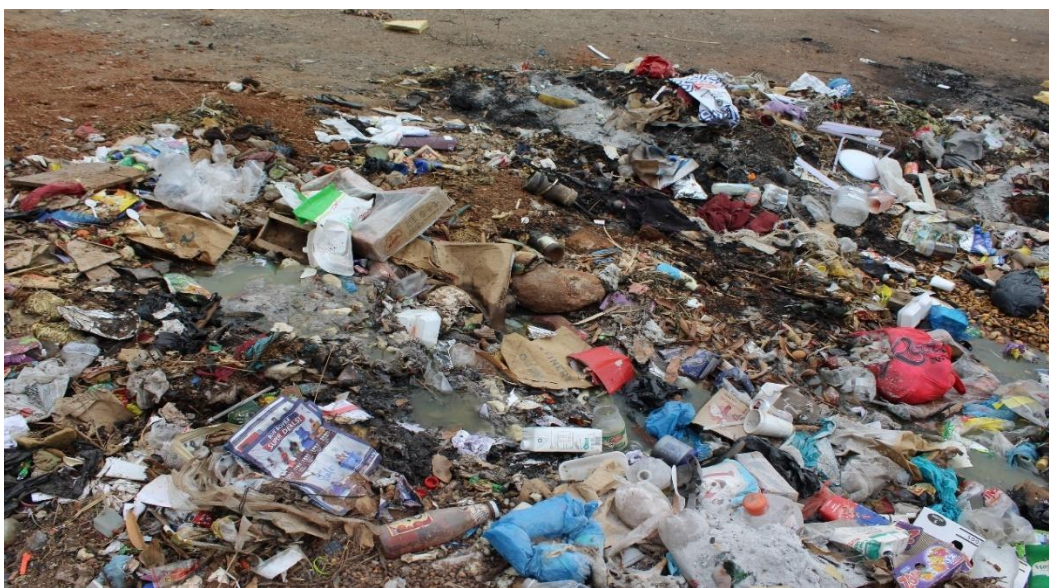
Picture 14: The extent of dirt dumped in the area and raw sewage

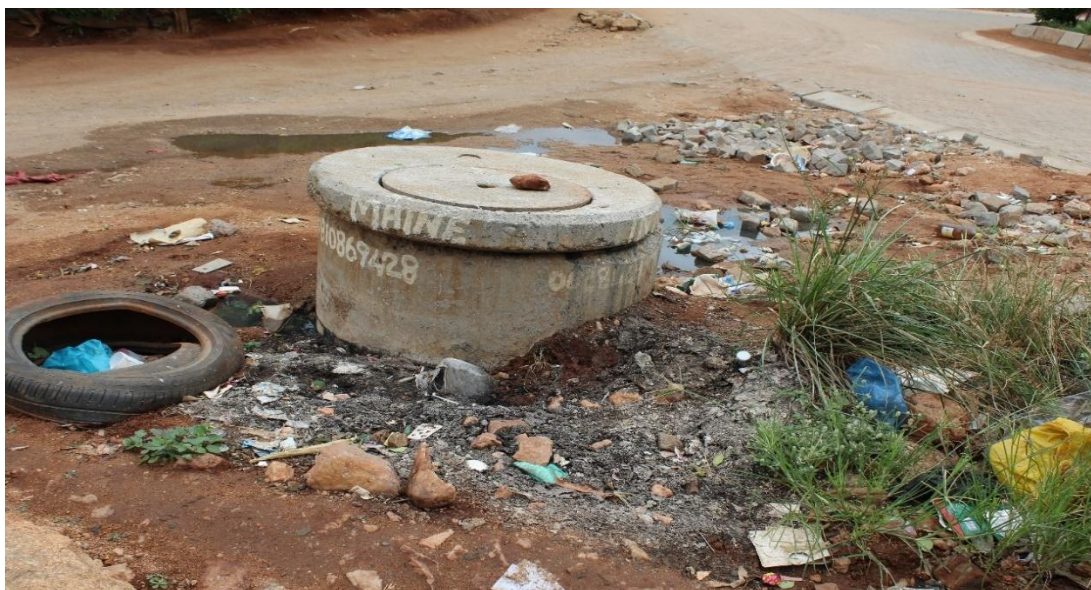
Picture 15: Dry sewage in another manhole

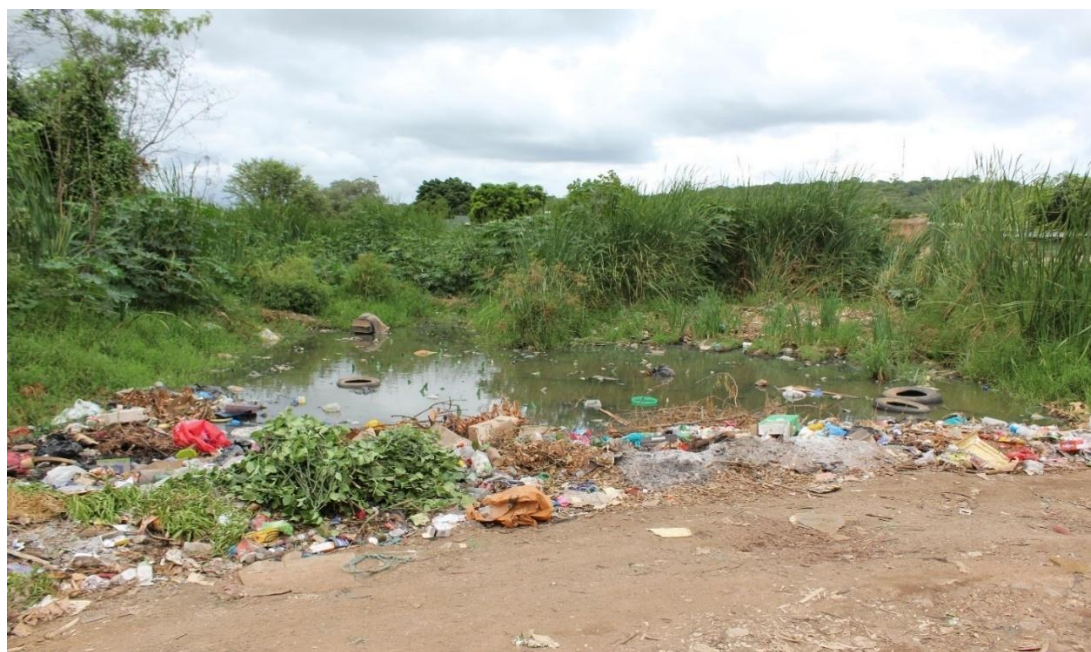
Picture 16: The stream, overgrown reeds and dirt

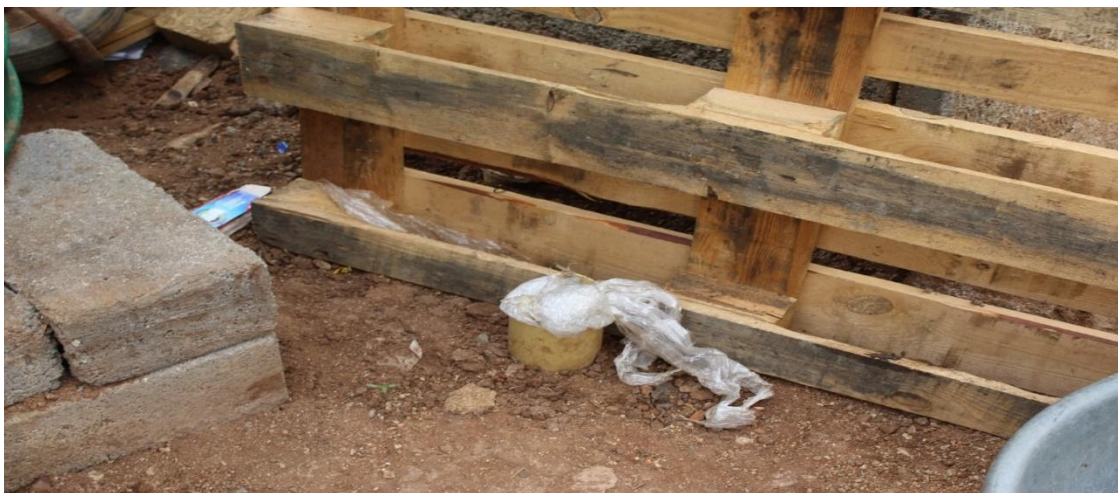
- 6.1.34 To avoid the spillage in his yard, a resident had to hire a plumber to direct the spillage from the pipes in his yard to the dumping area outside.

Picture 17: Pipe connected by a resident to direct raw sewage from his yard to the street

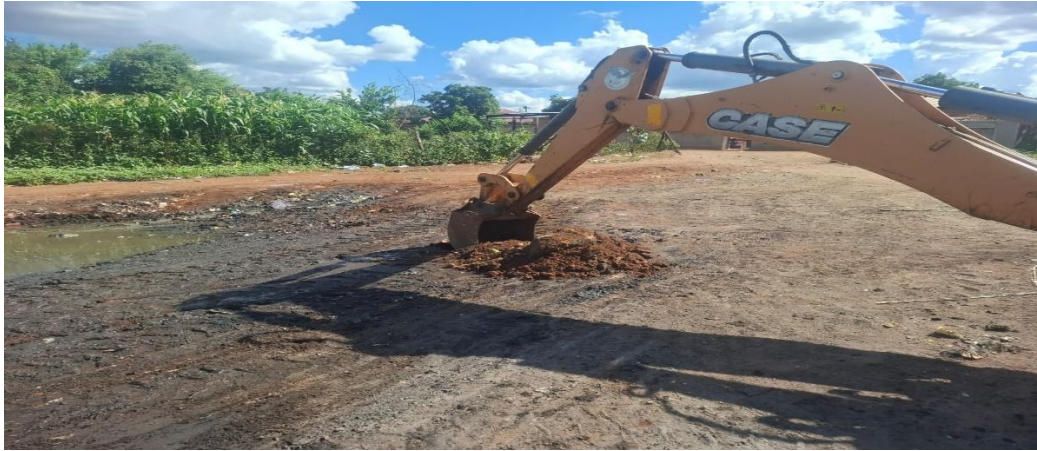
Picture 18: TLB cleaning the area (Courtesy of VDM)

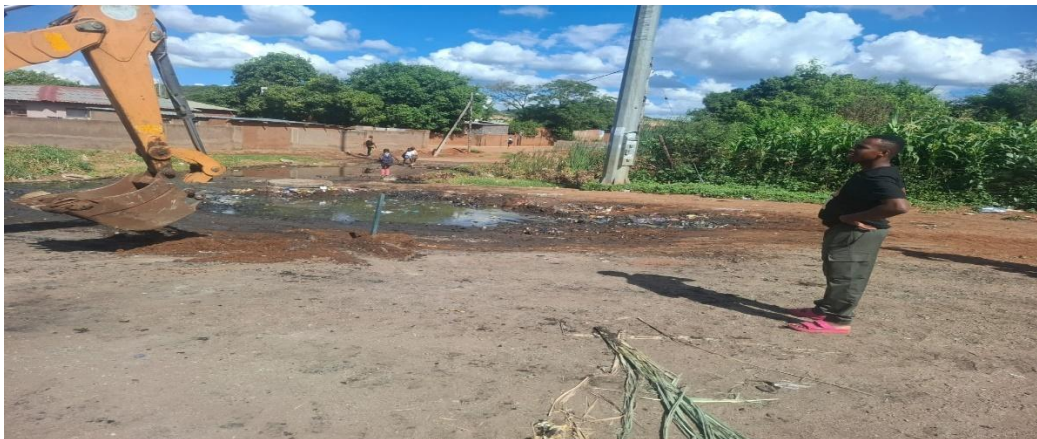
Picture 19: Cleaned area with wastewater (Courtesy of VDM)

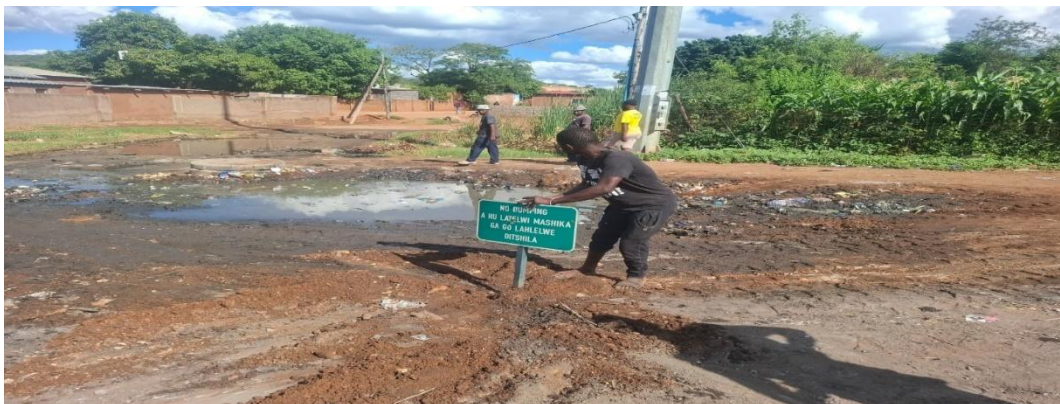
Picture 20: Municipal official placing a no-dumping sign (Courtesy of VDM)

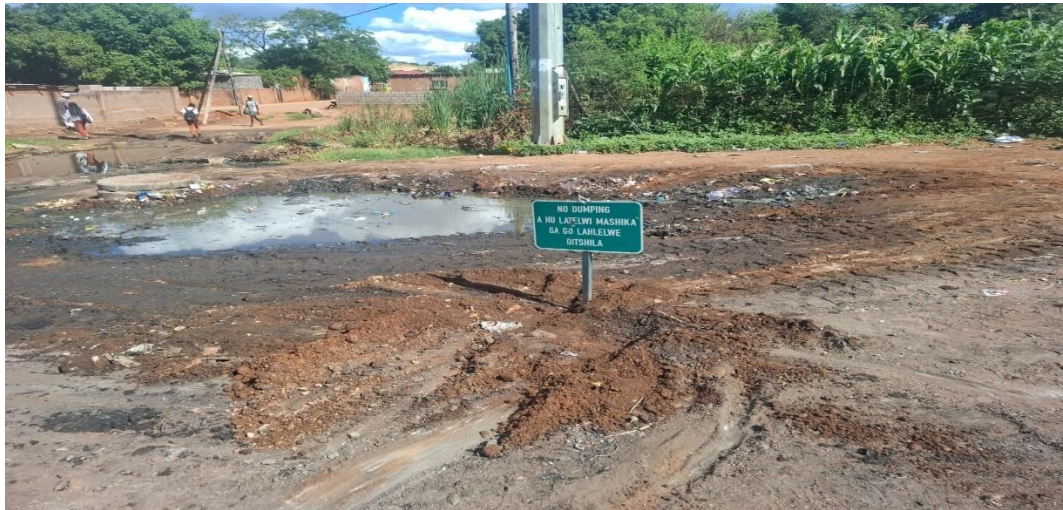
Picture 21: The area after it was cleaned (Courtesy of VDM)
