PUBLIC PROTECTOR
SOUTH AFRICA

REPORT NO. 27 OF 2024/25

**INVESTIGATION INTO VARIOUS PUBLIC SCHOOLS IN THE
ZULULAND DISTRICT THAT WERE AFFECTED BY SEVERE
WEATHER CONDITIONS IN AUGUST 2023**

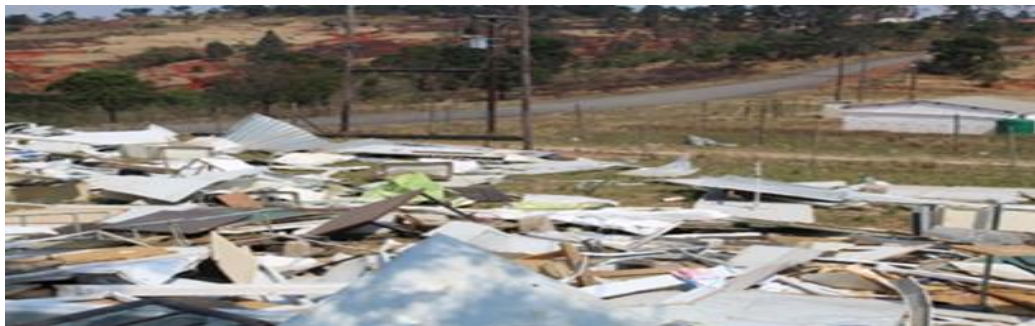
Figure 2: Classes destroyed by the storm

6.3.6 As a result of the natural disaster that occurred on 25 August 2023, Bantubaningi sustained severe damages; and several classrooms were destroyed by the storm.

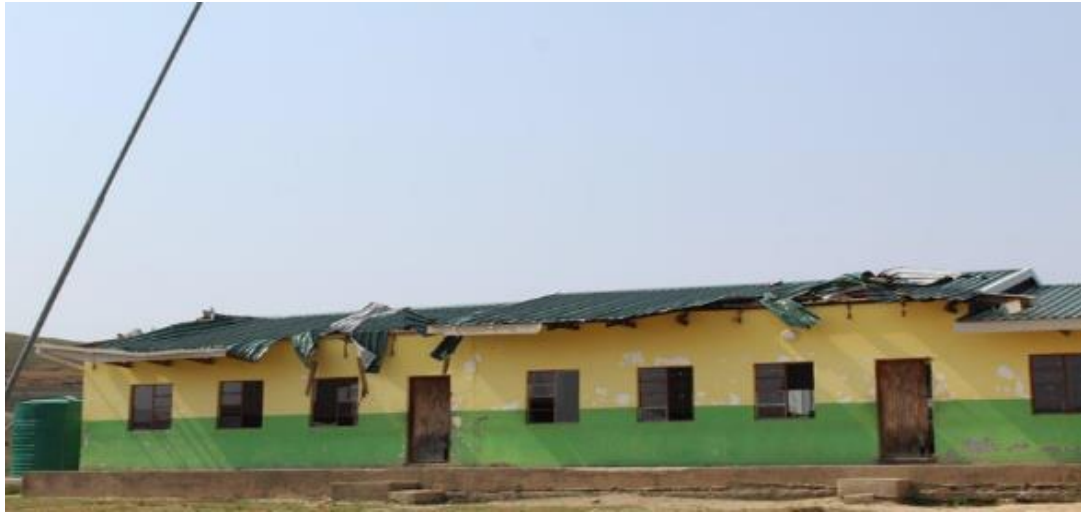
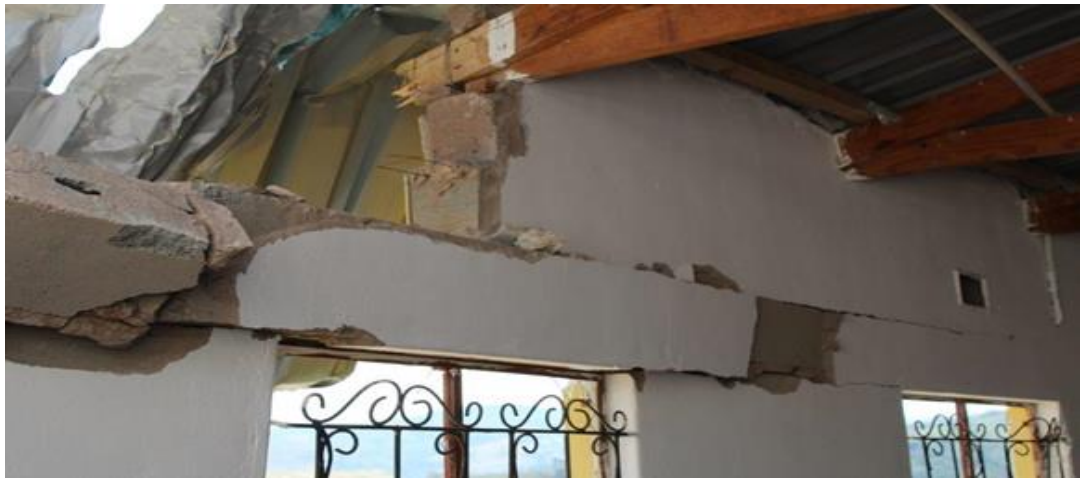
Figure 3: Uninhabitable classes damaged by the storm

6.3.7 Six (06) of the nine (09) classrooms were rendered uninhabitable, leaving the school with only three (03) partially damaged classrooms available for use as shown in the pictures below:

Figure 4: Uninhabitable classes damaged by the storm

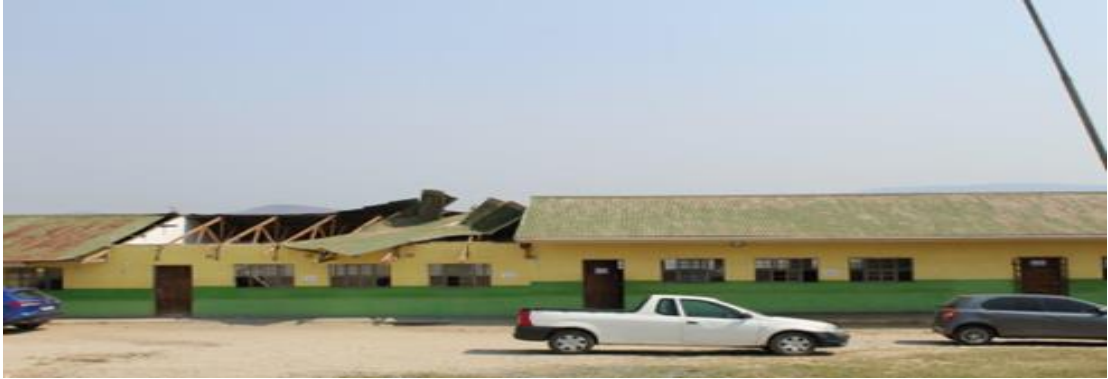
Figure 5: Partially damaged classrooms

6.3.8 The remaining classrooms were utilised to accommodate Grade 11 and Grade 12 learners, as the September Trial examinations had commenced on 04 September 2023.

- 6.3.12 The utilisation of the three (03) classrooms for exams posed a safety risk to both learners and educators due to the extensive structural damage.

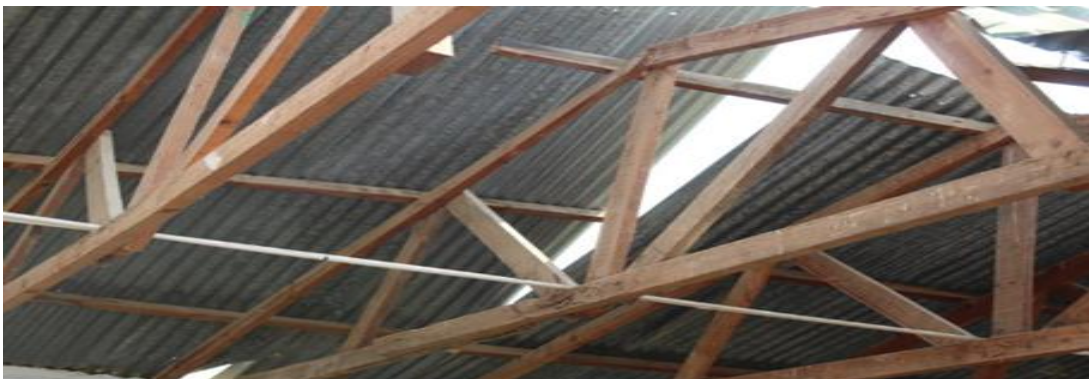
Figure 6: Damaged roof

- 6.3.9 Additionally, the storm caused damage to fourteen (14) steel cabinets, twelve (12) teachers' tables, and fifteen (15) laptops. The kitchen and kitchen utensils, including the stove, were also destroyed in the storm.
- 6.3.10 Due to the damage to the school's infrastructure, an interim measure was implemented where all Grade 11 learners were accommodated into one (01) classroom, whilst two (02) classrooms were designated as exam rooms for Grade 12 learners who were writing trial examinations.

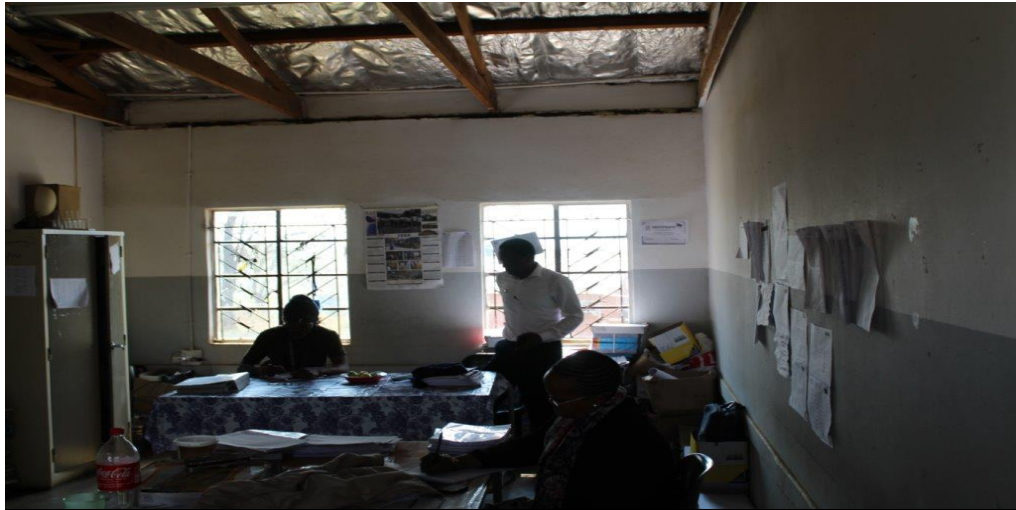
Figure 8: Principal's office

- 6.3.17 There was a shortage of lockable cabinets, and the administration block was in a dilapidated condition. Important documents and books were stored on tables and in boxes due to the lack of proper storage facilities.

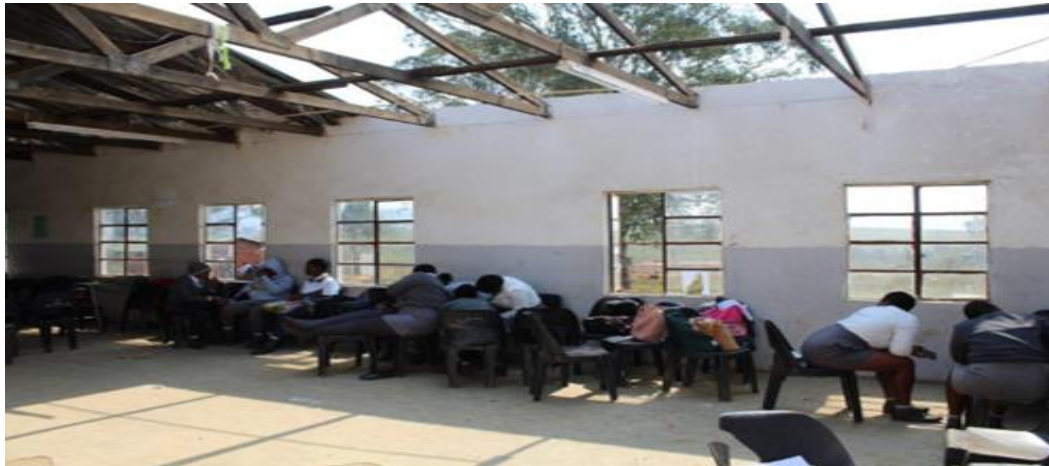
Figure 9: Classrooms with broken windows and doors

- 6.3.18 Several classrooms did not have doors and had broken windows, compromising the security and learning environment of **both teachers and** students.

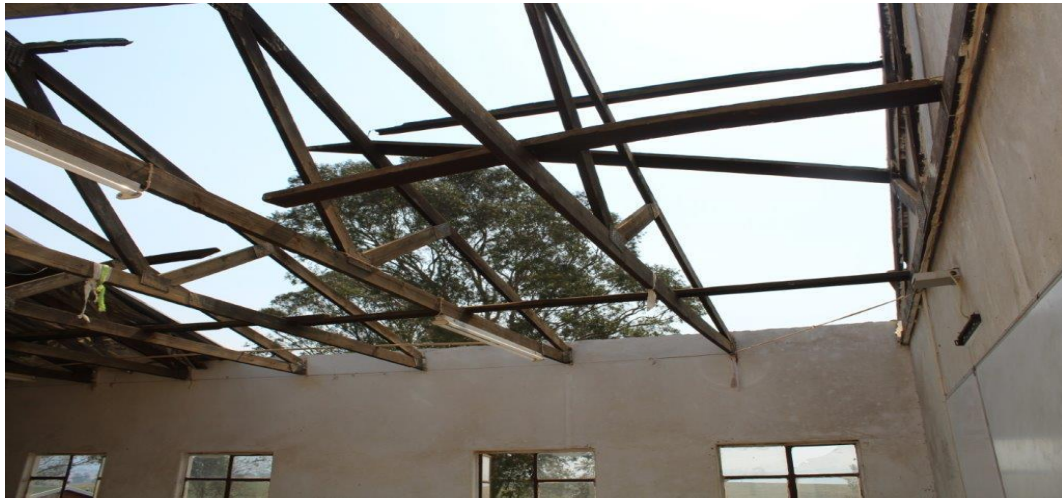
Figure 10: Damaged roof

- 6.3.22 Mhlambansila sustained damage to the school hall, which was utilised as a Grade 12 classroom. The hall was critical as it accommodated ninety-five (95) Grade 12 learners. The damage further strained the school's capacity to provide adequate learning space for its learners.

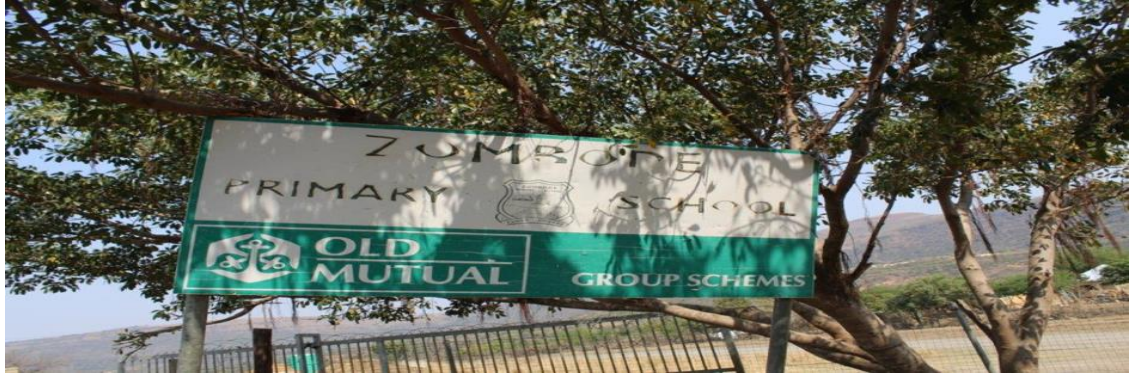
Figure 11: Fencing at the school

- 6.3.28 The general physical condition of the school and the surrounding environment was in a dilapidated state, necessitating a total upgrade. The school grounds were uneven and not paved, resulting in significant mud accumulation during rainy periods. The school was not accessible to individuals with physical

disabilities. The school yard was properly fenced, and the gates were locked during teaching and learning hours.

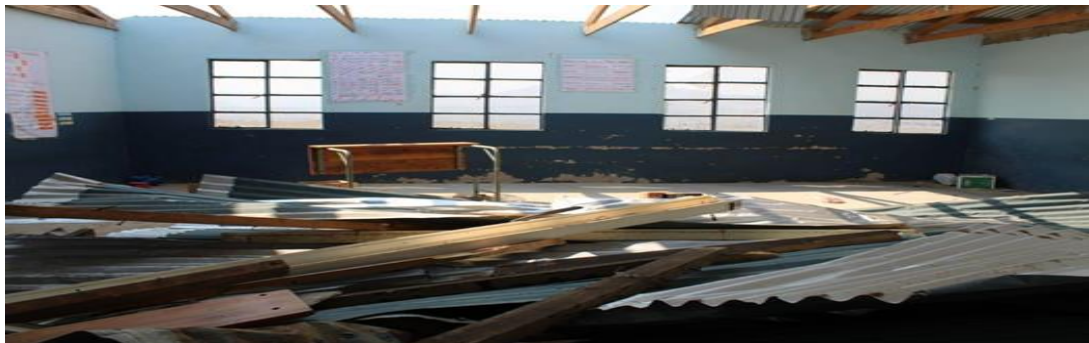
Figure 12: Damaged of classrooms

6.3.29 The school is comprised of two (02) main blocks and four (04) prefabricated classrooms. One block sustained complete damage and was unusable, whilst the other block was fully functional, featuring newly installed windows, doors and recent paintwork.

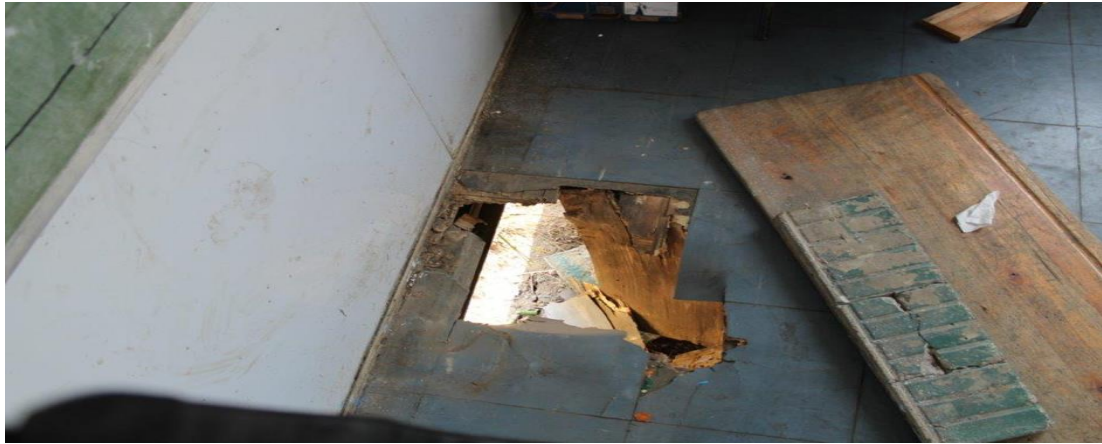
Figure 13: deteriorating mobile classrooms floors

6.3.30 The floors of the prefabricated classrooms were deteriorating, with multiple holes posing a safety hazard to learners and educators. Additionally, the stairs leading to the classrooms were damaged, making it unsafe for people to enter and exit without having to jump.

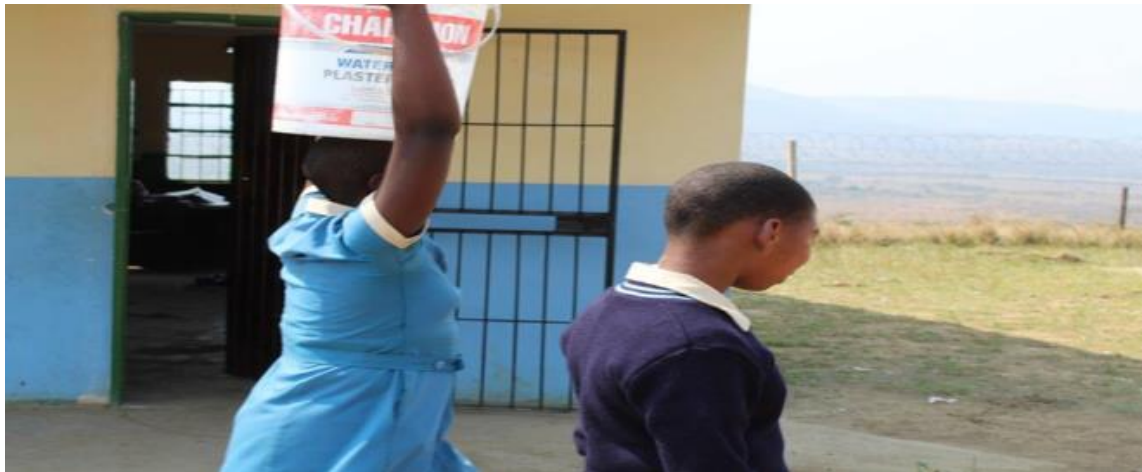
Figure 14: Learners fetch water from a neighbouring house

- 6.3.31 The school did not have access to electricity and water. Although a borehole was installed in 2021, it ceased functioning in September 2021. As a result, learners fetch water from a neighboring house during school hours.

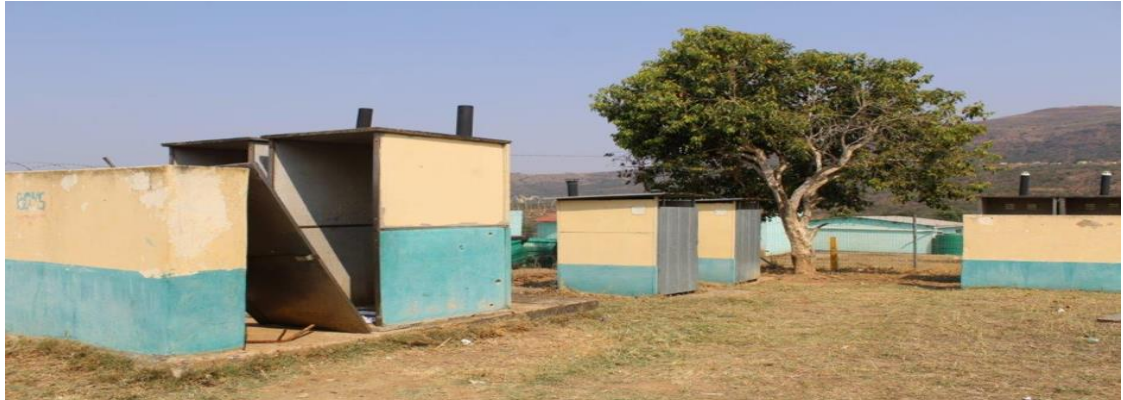
Figure 15: Ablution facilities in poor condition

- 6.3.32 There are insufficient lockable cabinets, and the school lacked a dedicated administrative block. Important documents and books were stored on tables and boxes in one of the prefab classrooms, which served as both the principal's office and staff room.
- 6.3.33 The school has pit toilets available for both learners and staff, however, the

ablution facilities were in poor condition, with broken windows and doors.

- 6.3.34 Additionally, the roofs of some of the toilets had been blown off, further compromising their functionality, safety and hygiene.

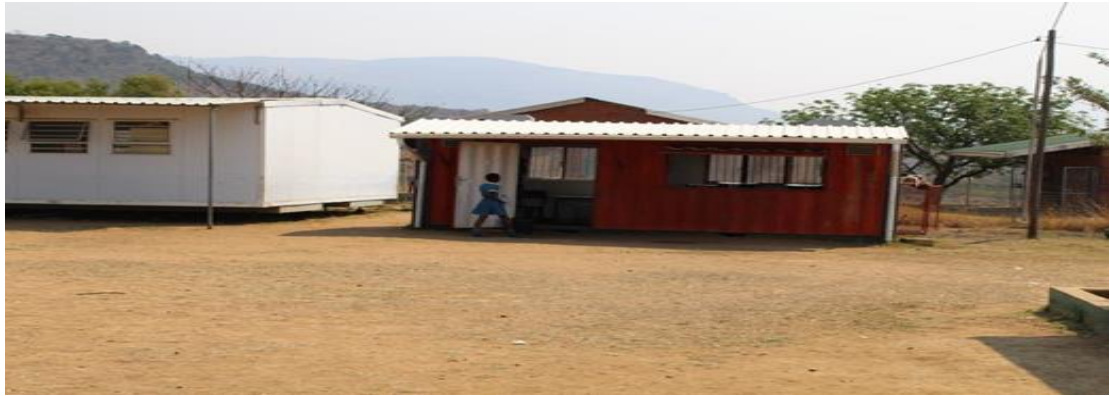
Figure 16: Mobile container utilised as a kitchen

- 6.3.35 Ms Mbuli reported that extensive damage already occurred due to a storm in 2018, which rendered one block of the building uninhabitable.
- 6.3.36 As an interim measure, the school was issued with prefabricated classrooms to ensure continuity in teaching and learning. Unfortunately, these prefabricated classrooms also suffered damage during the 25 August 2023 storm.
- 6.3.37 Additionally, the school's prefabricated kitchen was completely destroyed during the 2018 storm, and the school was, at the stage of the inspection, utilising a container as a mobile kitchen.

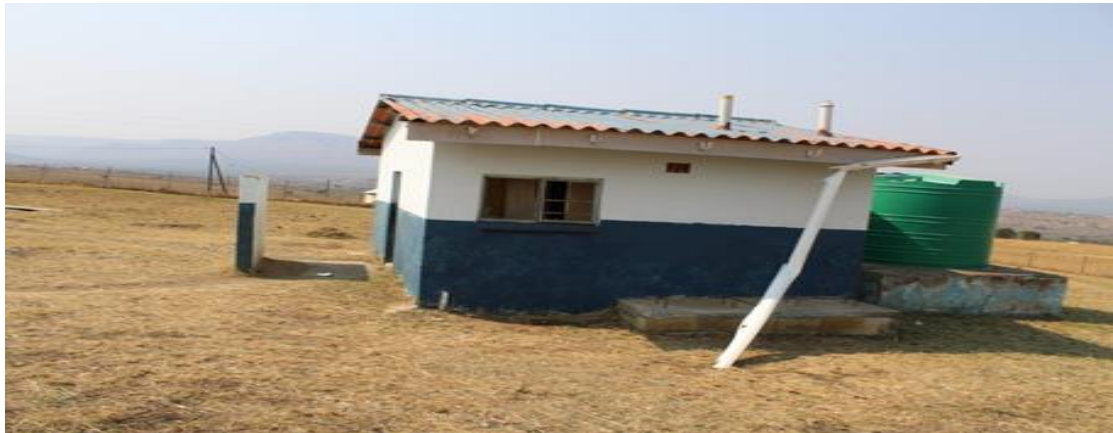
Figure 17: Jojo tank in good condition

- 6.3.45 The school has electricity and access to water. It is equipped with four (04) Jojo tanks for water storage. However, three (03) Jojo tanks were damaged during the storm, leaving only one (01) functional. The school received assistance from the Municipality for the refilling of the water tanks.

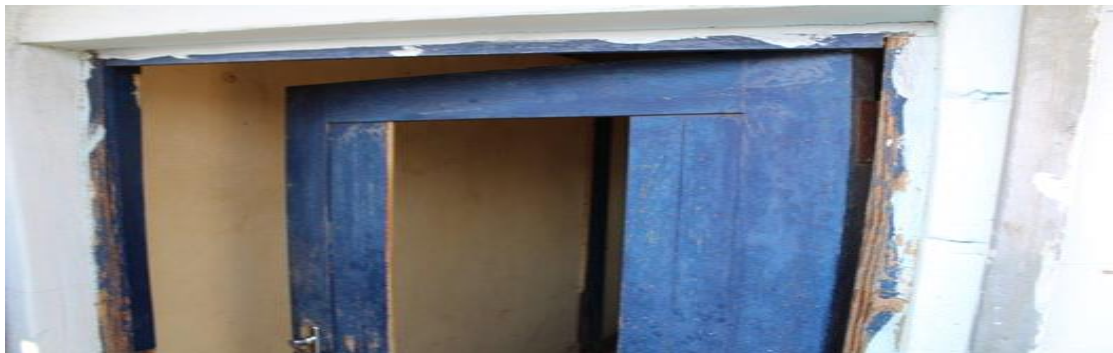
Figure 18: ablution facilities with broken doors

- 6.3.1.4. The school utilises pit latrines for both learners and staff, however, the doors and windows to the pit latrines were damaged. There was no access to water for handwashing after use.

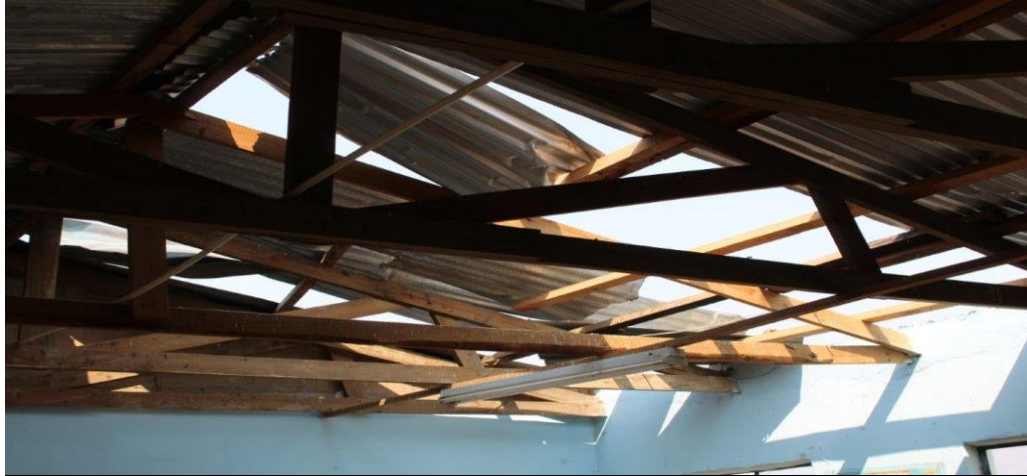
Figure 19: Damaged classroom

- 6.3.1.5. Several classrooms had broken windows as a result of the storm. The prefabricated classrooms sustained damage, with pieces of steel protruding from the floors, which posed a significant safety hazard to both educators and learners alike. These protruding pieces of steel were present at multiple locations throughout the classrooms and alongside various holes in the floors.

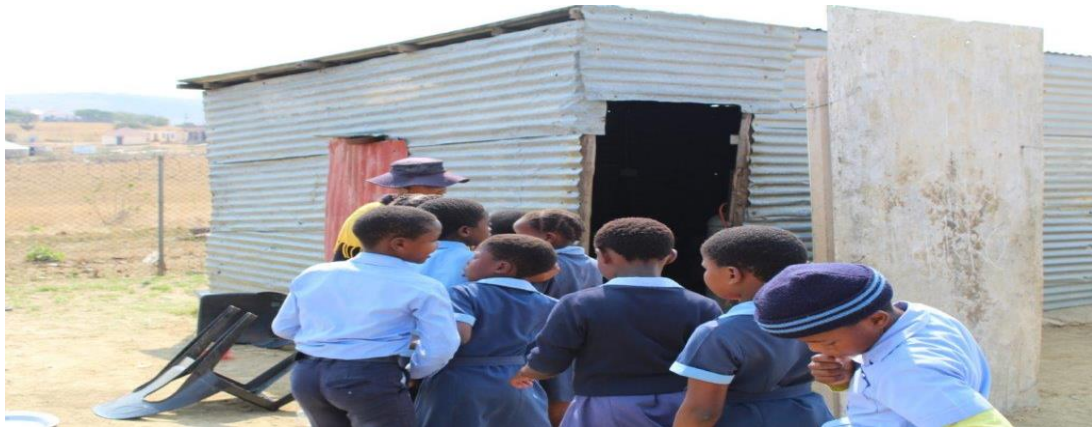
Figure 20: informal structure utilised as a kitchen

- 6.3.1.6. During the inspection, the school was utilising an informal zinc structure as a kitchen as shown below:

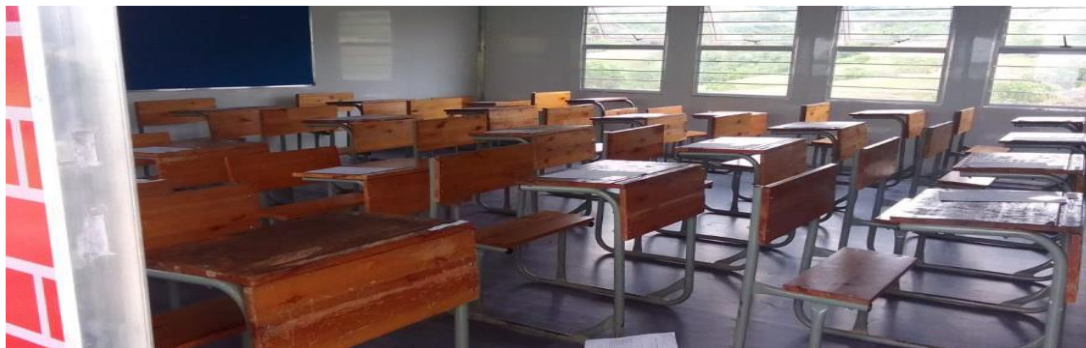
Figure 21: Procured prefabricated classrooms

6.3.18.2. The DoE engaged with the Independent Development Trust (IDT) as the Implementing Agent to facilitate the procurement of mobile classrooms as an interim measure and to initiate rehabilitation of the storm damage.

6.3.18.3. The IDT provided two (02) Implementation Plans addressing interim measures and permanent interventions. The DoE also explored the availability of mobile classrooms in districts that were unutilised or under-utilised to expedite delivery and installation.

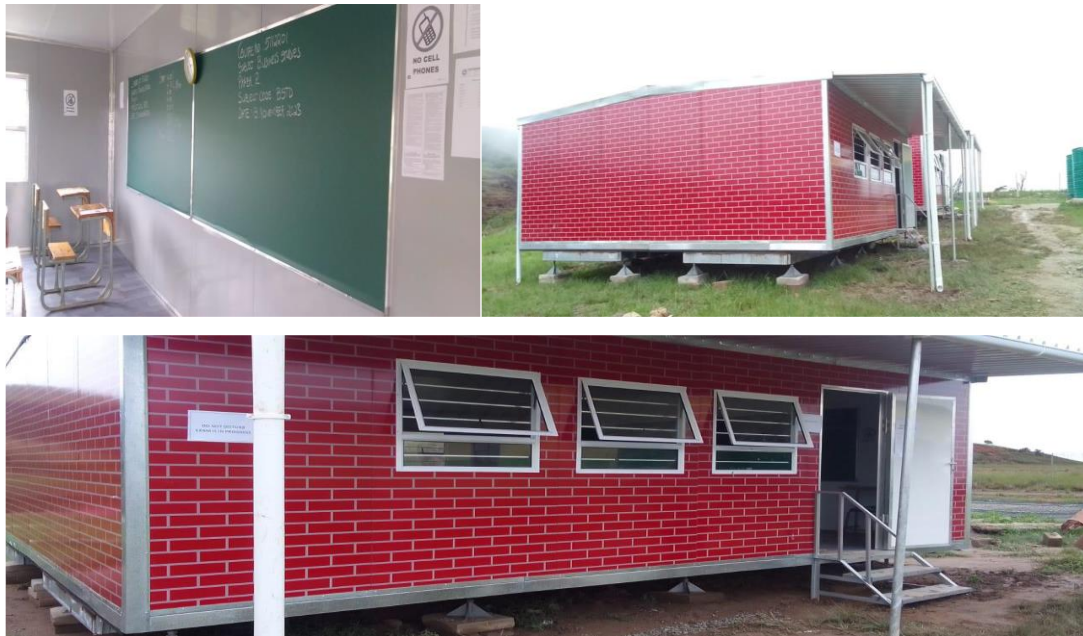
Figures 22: Mobile classrooms delivered at Bantubaningi

6.3.18.6. In conclusion, DoE shared pictures of three (03) mobile classrooms that had already been commissioned, delivered and installed at Bantubaningi as shown in the pictures below:

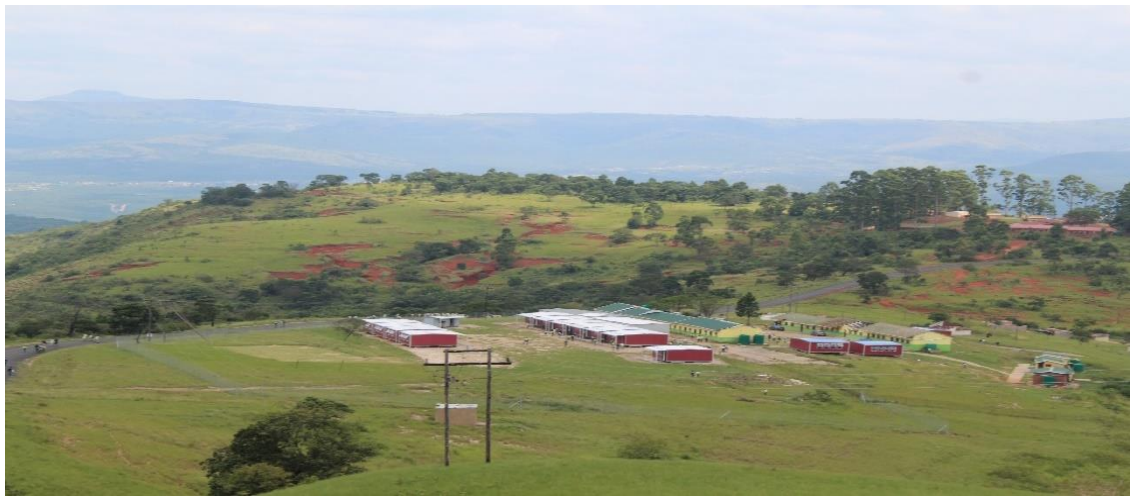
Figure 23: Mobile classrooms delivered at Bantubaningi

6.3.20.1. The DoE delivered fourteen (14) mobile classrooms and one (01) mobile kitchen to the school. As part of the plan to relocate the school to a new site adjacent to the current location, eleven (11) mobile classrooms were set up on the new site and were already in use for teaching and learning.

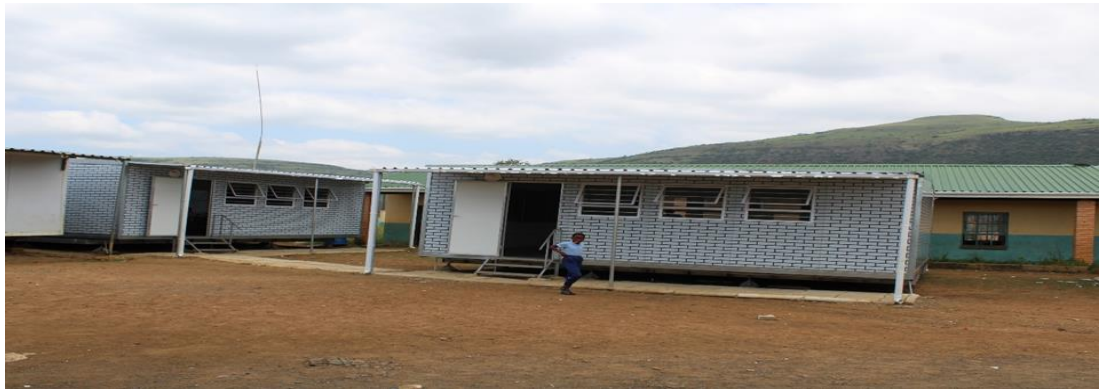
Figure 24: Mobile classroom and a kitchen delivered at Mhlambansila

- 6.3.20.5. The Investigation Team previously noted that Mhlambansila was not severely affected by the storms, except for one (01) classroom and a kitchen that were destroyed. During the onsite inspection, the DoE had already delivered one (01) mobile classroom and one (01) fitted mobile kitchen, as requested by the school as shown in the picture below:

- 6.3.20.6. The SGB completed minor repairs to the classroom that suffered slight damage during the storm on 25 August 2023. No further urgent issues requiring intervention by the DoE were reported.

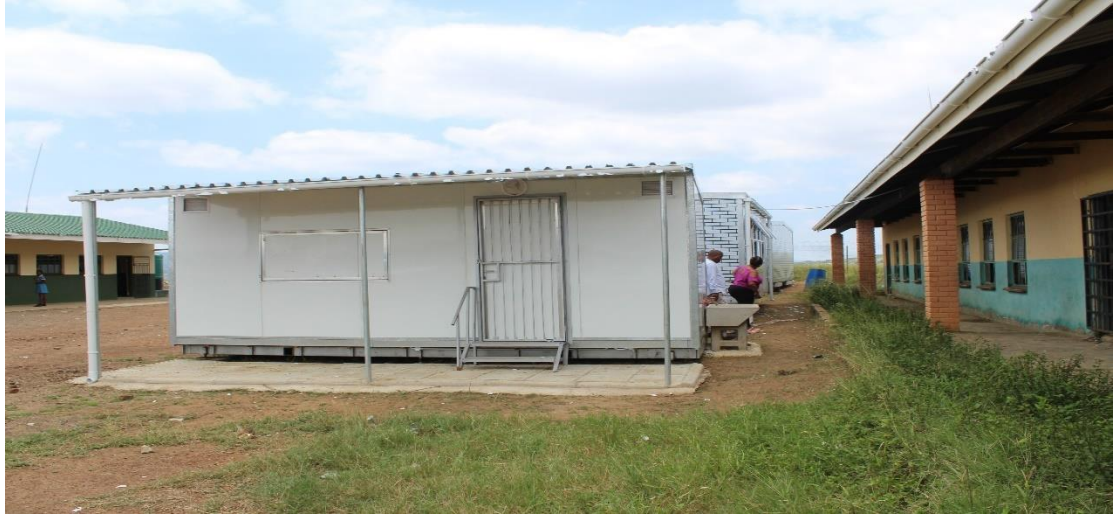
Figure 25: Mobile classrooms delivered at Zombode

three (03) mobile classrooms and one (01) mobile kitchen that had been destroyed in the storm had been replaced by DoE. The classrooms and kitchen were in full use by the school during the inspections.

6.3.20.8. However, it was noted that the newly delivered mobile classrooms sustained damage due to another natural disaster that occurred in mid-February 2024, just prior to the inspection.

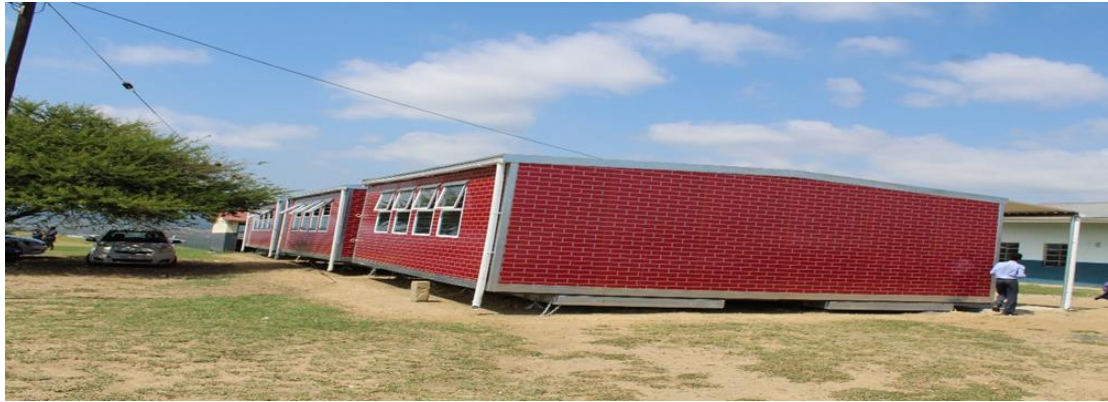
Figure 26: Three mobile classrooms delivered at Philibana

6.3.20.10. Philibana initially reported three (03) classrooms and a kitchen that were demolished by the storm. The DoE delivered three (03) mobile classrooms and one (01) fitted mobile kitchen, which were in use by the school.

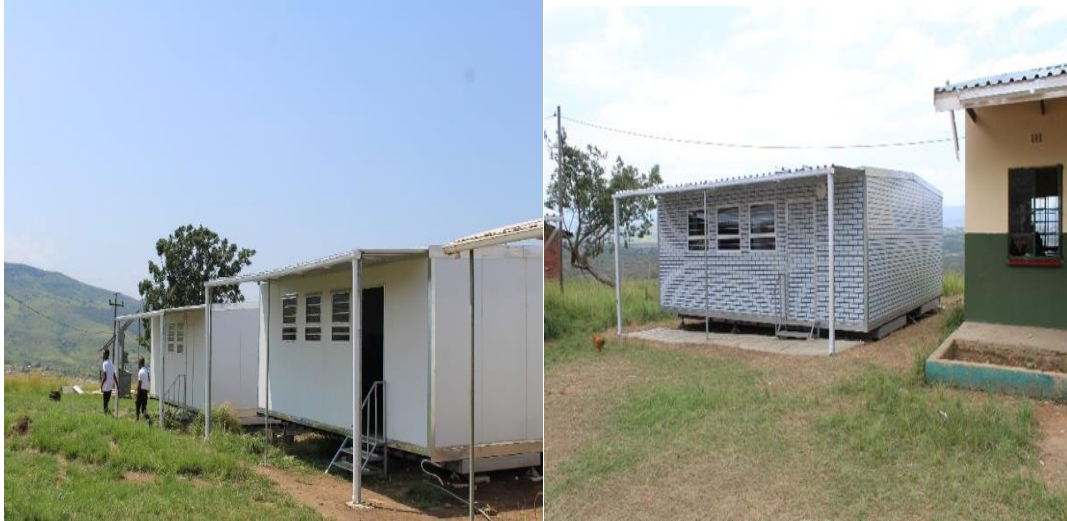
Figure 27: Three mobile classrooms delivered at Sizabonke

- 6.3.20.11. Sizabonke which was reported by the school principal, Mr Mntambo during a stakeholder engagement with the Public Protector on 09 November 2023. Was also included in the investigation for intervention by the DoE.
- 6.3.20.12. The Investigation Team visited the school for the first time on 23 February 2024, wherein the school principal, Mr Mntambo reported a shortage of classrooms and the need for at least three (03) mobile classrooms, as the ones they had were demolished during the natural disaster.
- 6.3.20.13. The DoE has since delivered three (03) mobile classrooms to the school and the school principal has indicated that he is satisfied with the intervention.
- 6.3.20.14. There were no further issues reported that still needed urgent intervention by the DoE.

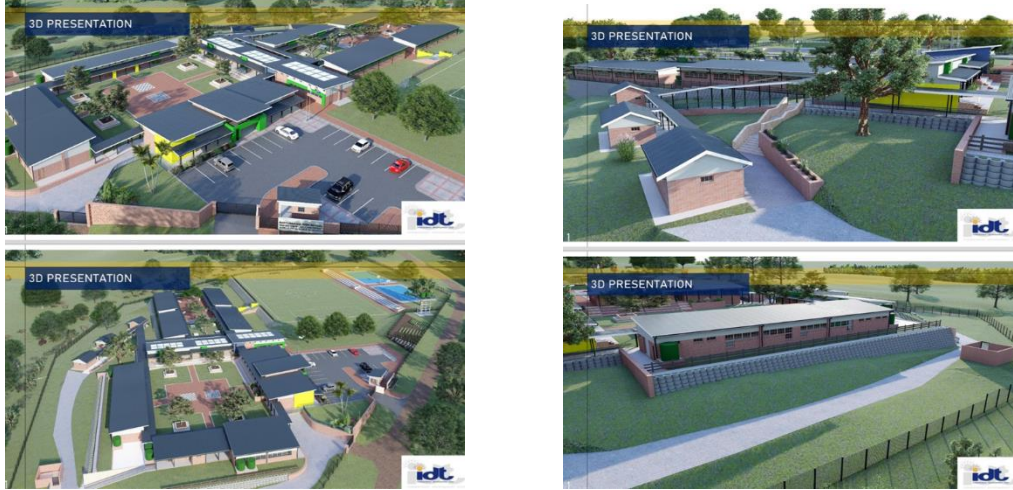
Figure 28: Permanent architectural design for the reconstruction of Bantubaningi

6.3.32. According to the final report, Bantubaningi required permanent intervention in the form of reconstruction of the entire school. The pictures below reflect the permanent architectural design for the reconstruction of the entire school:

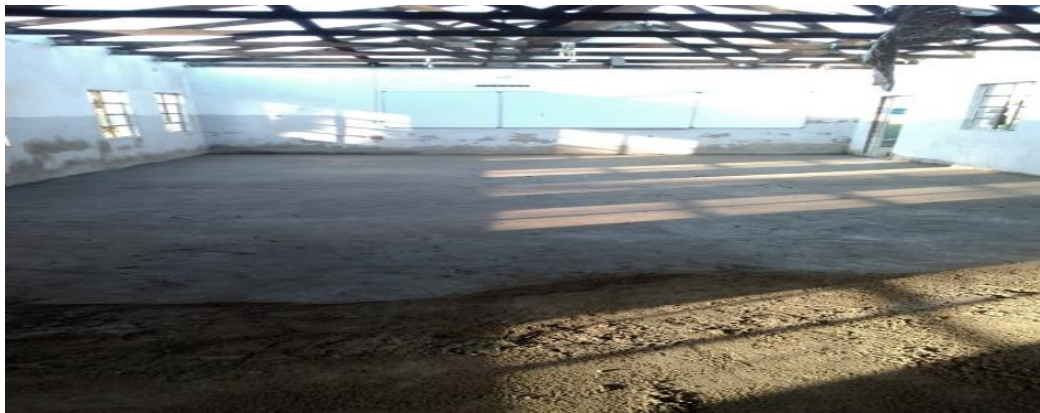
Figure 29: Progress at Mhlambansila

- 6.3.36. The site was handed over on 06 March 2024, with an anticipated finish date of 31 October 2024. The contract amount is nine million five hundred and thirty-eight thousand two hundred and fifty-eight rand and sixty-four cents (R 9 538 258.64) and the expenditure a 26 September 2024 was two hundred and twenty four thousand and twelve rand and twenty one cents (R 224 012.21).
- 6.3.37. The progress on the implementation of the project was reported at 15% complete. The pictures below reflect the progress made by the DoE on the interim intervention provided at Mhlambansila:

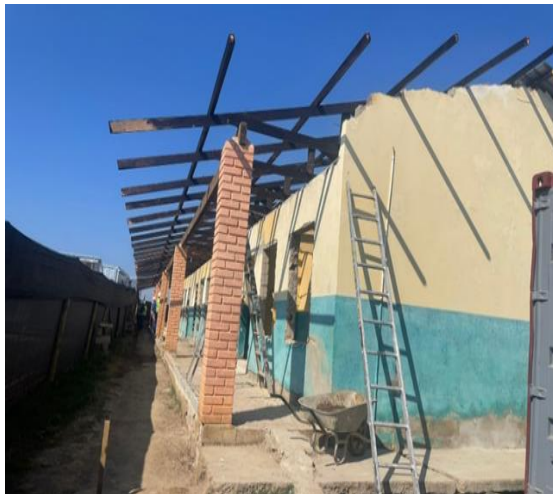
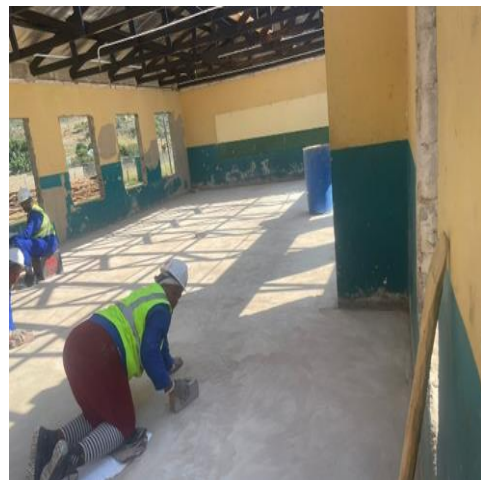
Figure 31: Progress made at Zombode

- 6.3.39. The implementing agent appointed at Zombode was IDT whilst the contractor was Morefortune Holdings PTY (Ltd).
- 6.3.40. The site was handed over on 25 March 2024, with an anticipated finish date of 31 October 2024. The contract amount was five million nine hundred seventy-five thousand three hundred forty-one rand and thirty five cents (R 5 975 341.35) and the expenditure on 26 September 2024 was zero rand (R 0,00). Progress on the implementation of the project was reported at 85% complete.

- 6.3.41. The pictures below reflect the progress made by the DoE on the permanent intervention provided at Zombode:

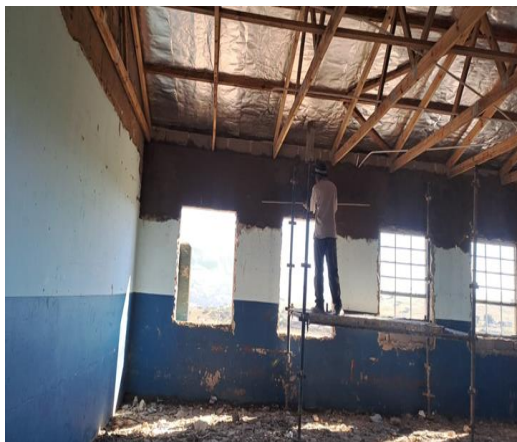
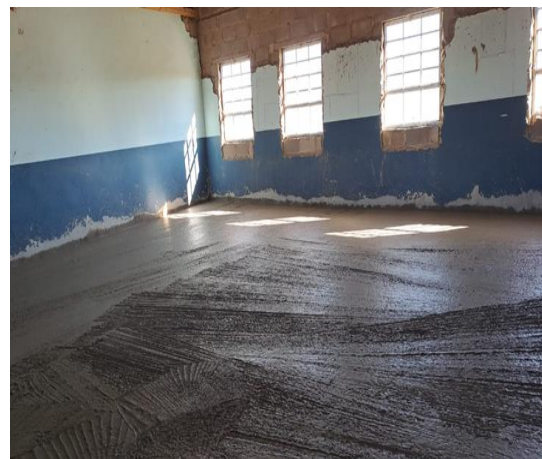
Figure 32: Progress made at Philibana

- 6.3.44. The site was handed over on 05 April 2024 with an anticipated finish date of 31 October 2024. The contract amount was nine million sixty-eight thousand seven hundred fifty six rand and seventy five cents (R 9 068 756.75) and the expenditure on 26 September 2024 was three million one hundred ninety four thousand six hundred ninety six rand and twenty five cents (R 3 194 696.25).

- 6.3.45. The progress on the implementation of the project was reported at 54% complete. The pictures below reflect the progress made by the DoE on the permanent intervention provided at Philibana:
