**REPORT OF THE PUBLIC PROTECTOR IN TERMS OF SECTION 182(1)(b) OF THE
CONSTITUTION OF THE REPUBLIC OF SOUTH AFRICA, 1996 AND SECTION 8 (1) OF THE
PUBLIC PROTECTOR ACT, 1994**

REPORT NUMBER: 02 OF 2023/2024

**INVESTIGATION INTO ALLEGATIONS OF FAILURE BY THE CITY OF EKURHULENI
METROPOLITAN MUNICIPALITY TO ENSURE THAT SEWAGE INFRASTRUCTURE
LOCATED ADJACENT TO THE PAN IN BIRCH ACRES, KEMPTON PARK IS
PROPERLY MAINTAINED**

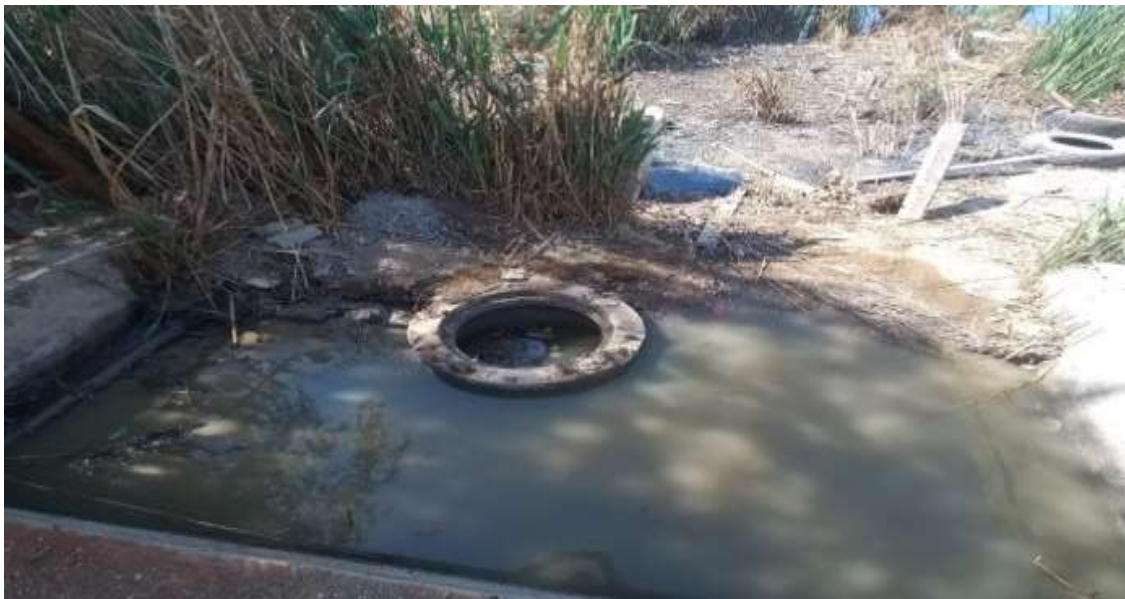
Picture 1: The Municipality's sewage manhole situated at back of the Church at 21 Pikkewyn Street overflowing with waste water

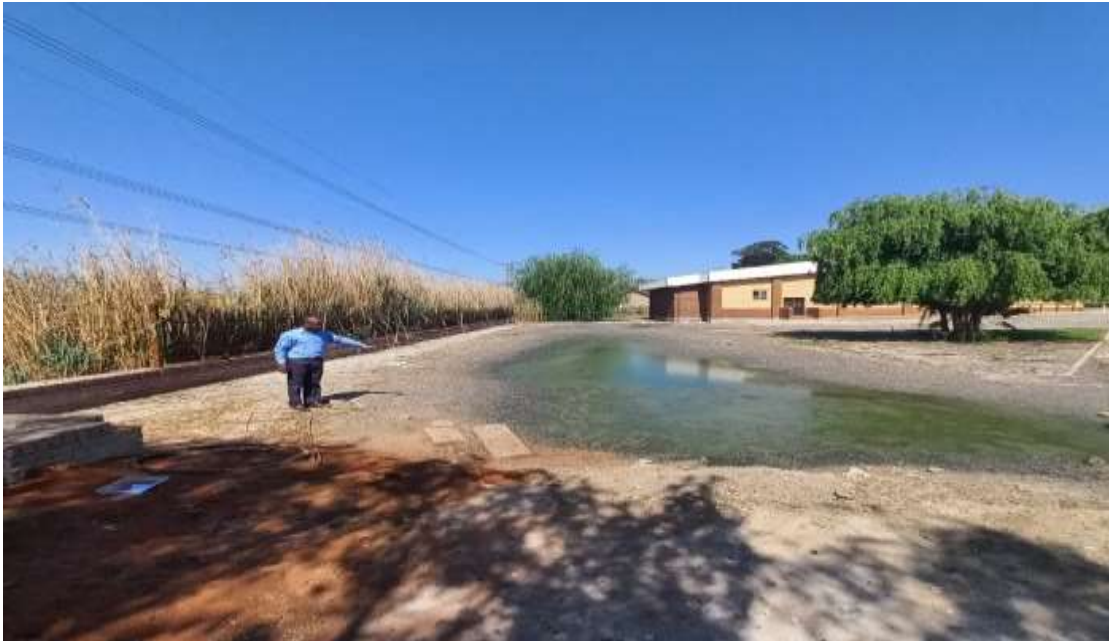
Picture 2: Sewage wastewater forming a pond at the church's back yard at 21 Pikkewyn Street.
